CELERITY GROUP, INC. 1463 Centre Pointe Drive  
Milpitas, CA 95035, USA

## FIELD SERVICE BULLETIN

**To:** Field Application and Distribution  
**From:** Norm Sellers, John Raditsas  
**Subject:** MFC Zeroing Procedure  
**Date:** 02.04.05

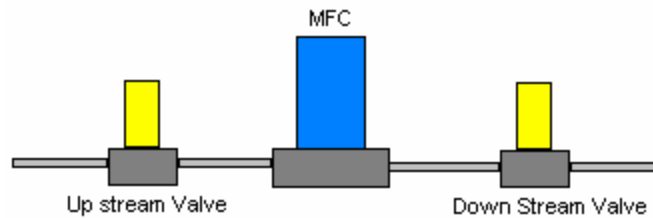
1. Be certain that the MFC has been inside the user equipment for a minimum of 4 hours and has been powered for a minimum of 60 minutes prior to re-zeroing.
  - This assures that the MFC is in its "use attitude" as well at operating temperature.
  - If the MFC is subjected to vacuum purge for more than one minute, you must turn off the MFC control valve and allow the MFC to settle for a time period equal to twice the vacuum purge time period.
2. Open the upstream isolation valve and close the downstream isolation valve to eliminate the pressure drop by isolating the MFC within the process tool.
  - The pressure drop across the MFC control valve must be eliminated so that the control valve leakage is not a factor.

3. Send the MFC a 100% full scale set point, and allow the system at least sixty seconds to equalize the pressure across the MFC control valve.
4. Shut the upstream isolation valve to prevent any creep effects in the regulator from affecting the pressure.
5. Close the MFC control valve and wait two minutes.
6. Read the output signal of the MFC.
  - This is now the zero offset, in percent F.S.
7. The MFC output signal should be 0% +/- 0.1% Full Scale.
  - This would be 0.1 SCCM for a 100 SCCM full scale MFC.
  - If you cannot read the output signal to the necessary resolution, you will need to assume that it needs adjustment.
  - If the flow is zero sccm, you will need to assume that it is negative and zero the MFC.
    - The controller is not set up to read negative flow.
